U. S. NAVAL AIR ENGINEERING CENTER

NAEC-ENG-7945

13 April 1978

DEVELOPMENT OF CORROSION RESISTANT FASTENING SYSTEMS FOR AIRCRAFT CARRIER STEAM CATAPULTS

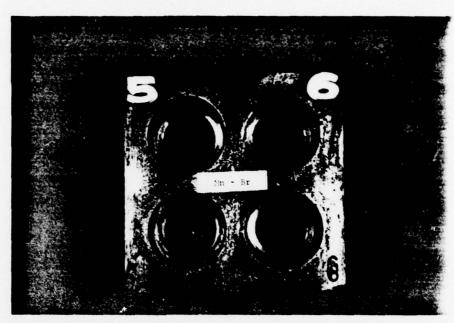
Photo 11. 9 month exposure of manganese bronze block at Ocean City produced staining when nickel overcoated with cadmium plated screws were used in it. See Table XVII.
